Inspection details for

# 123 Example Road, Miami, FL 12345

<b>Property Address</b>	123 Sample Road, Miami, FL 12345
<b>Type of Building</b>	Single Family (2 story)
<b>Inspected By</b>	John Doe
<b>Inspected On</b>	January 1, 2024
<b>Weather</b>	Clear, Dry, Over 70
<b>In Attendance</b>	Customer, Agent
<b>Prepared For</b>	[Customer Name]

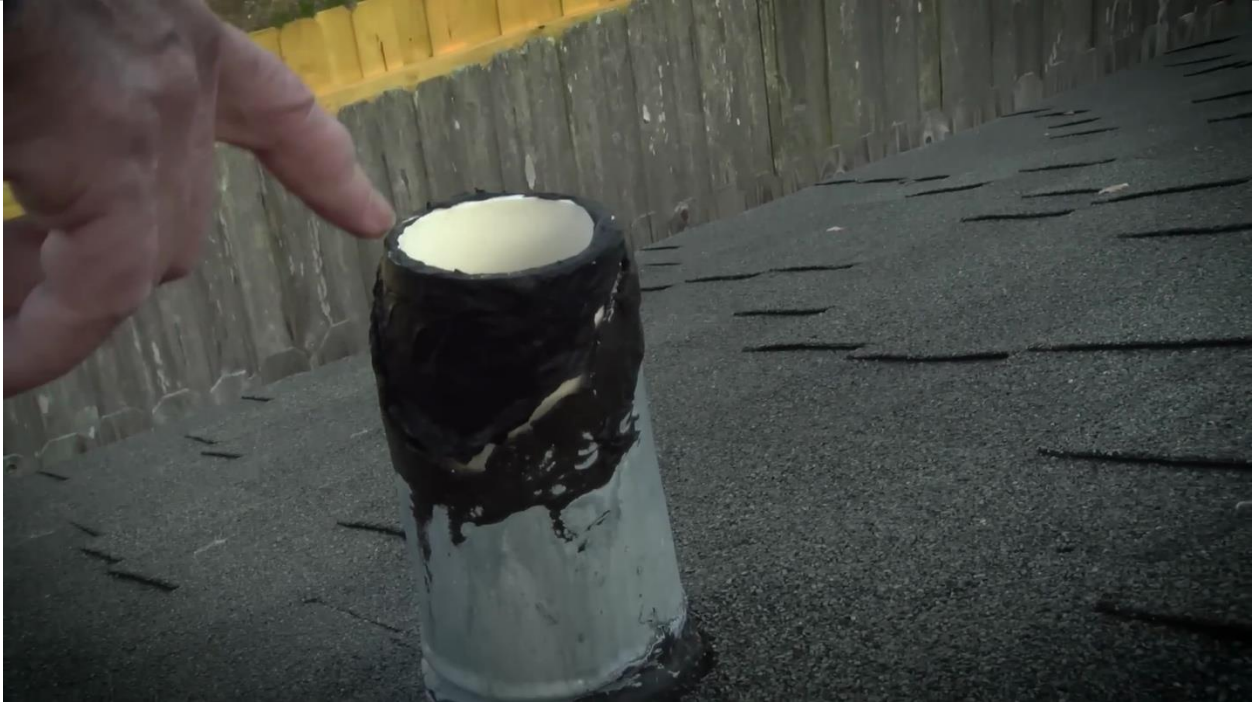
**G** **General Repair:** The boot around one stack pipe has been damaged by squirrels. A temporary repair was made, but it needs proper fixing to prevent moisture intrusion.

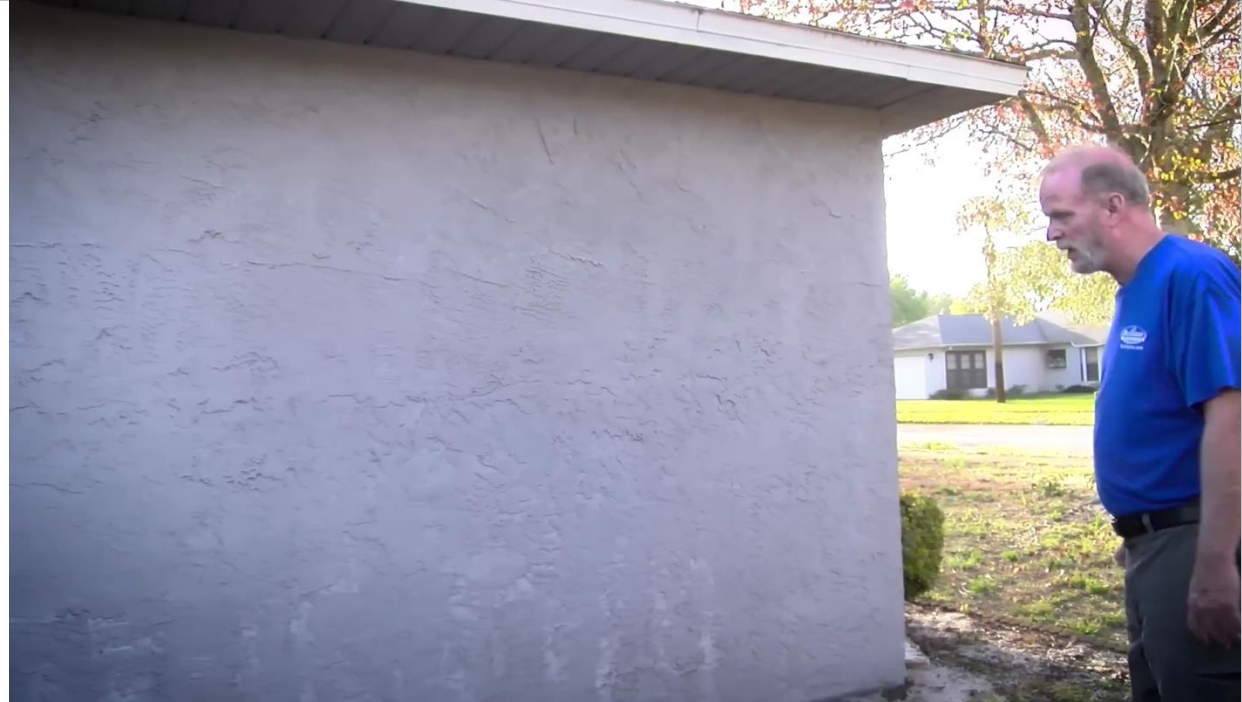
- G** **General Repair:** The stucco on the bay window shows signs of past repairs, indicated by different textures. The area may have experienced moisture intrusion due to improper water drainage. Repainting the exterior with elastomeric paint is recommended to seal cracks common in masonry construction.

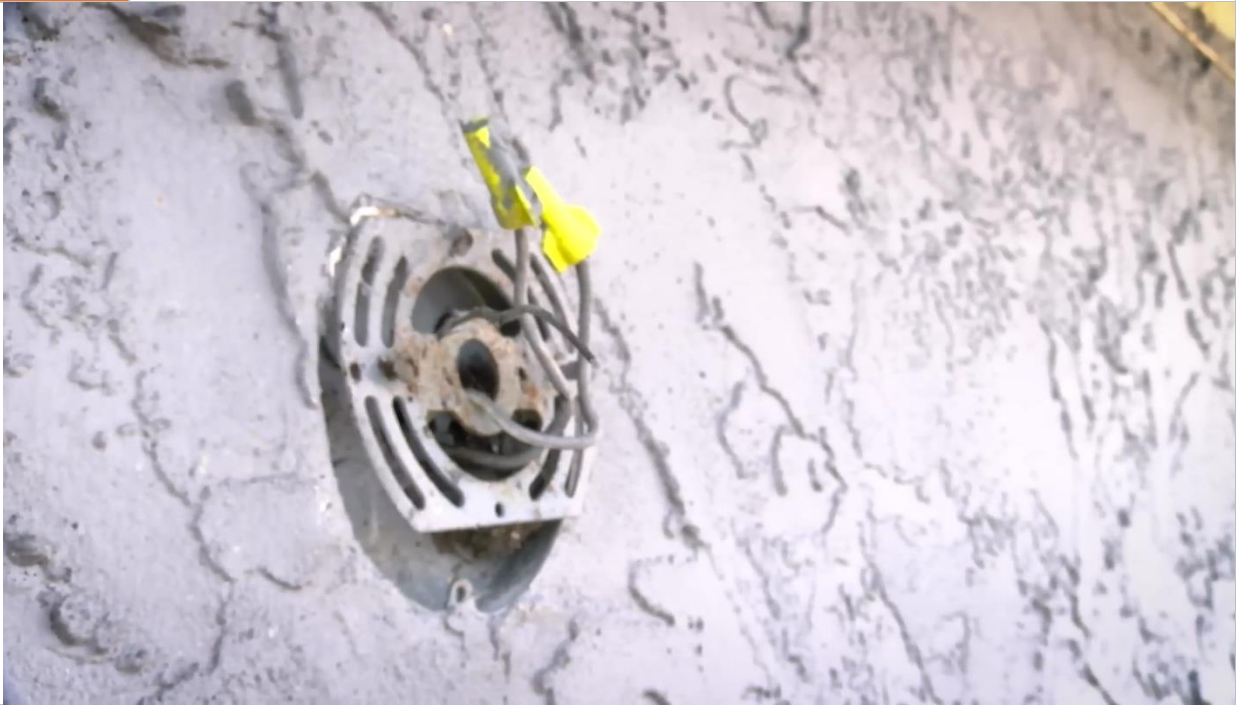
**S** **Safety (Immediate Concern):** Several exterior light fixtures are missing. These need to be replaced or covered with plates to prevent exposed wiring.

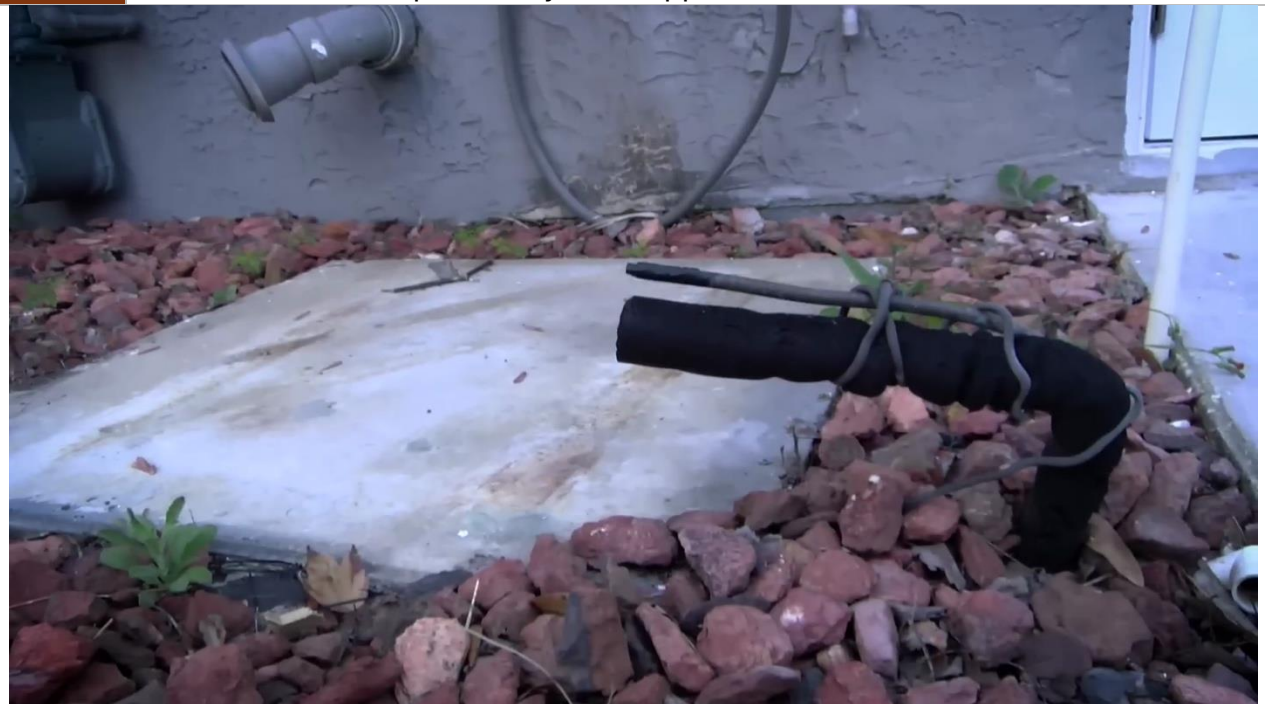
**M** **Defect (Major Concern):** The AC condenser unit is missing. Only the wiring and concrete pad remain. A new AC system needs to be installed, including a new condenser unit and potentially new copper lines.

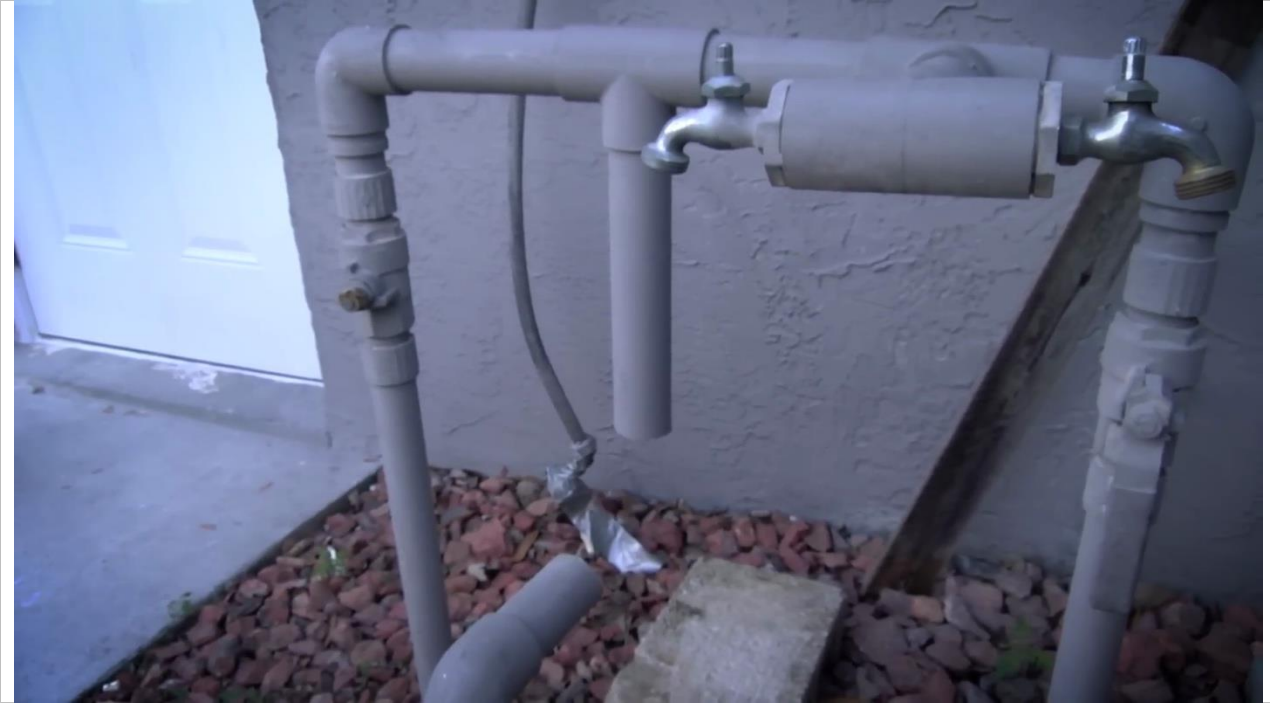
**M** **Defect (Major Concern):** The well pump for the sprinkler system is missing. The electrical connections are still in place, so a new pump needs to be installed to restore the sprinkler system's functionality.

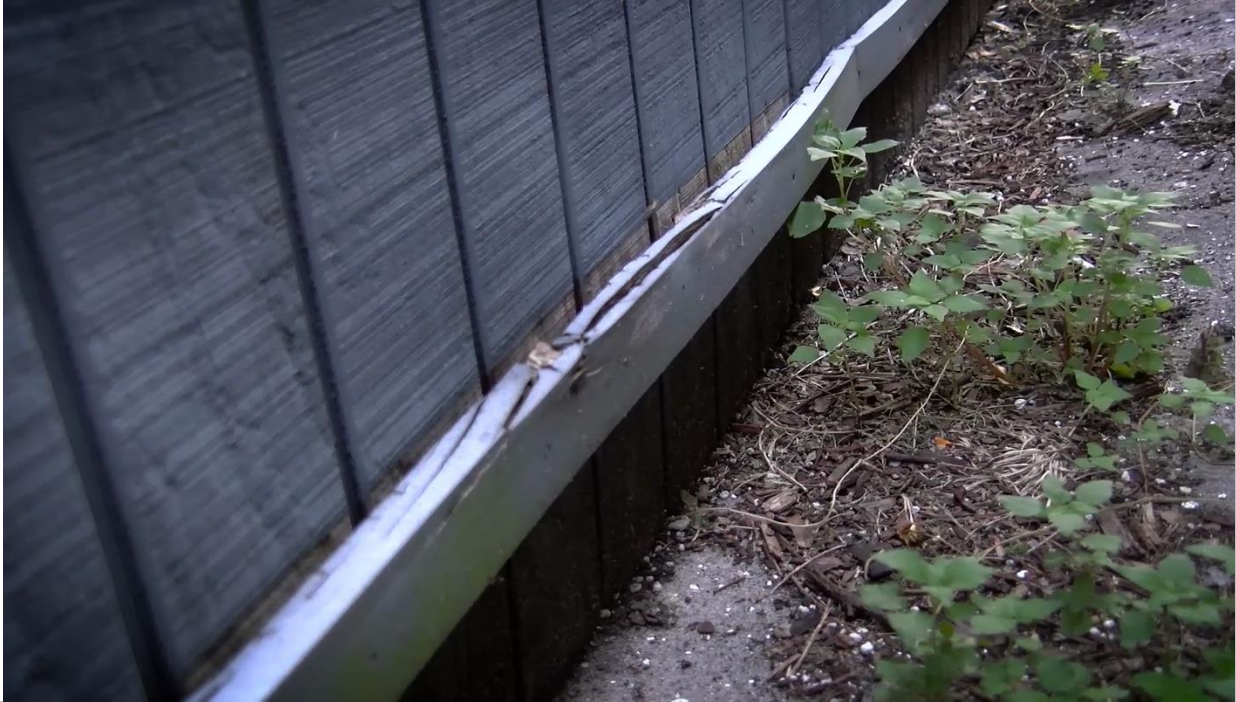
**G** **General Repair:** The storage building, which is made of wood, shows signs of decay. This is a common issue in Florida due to high moisture levels.

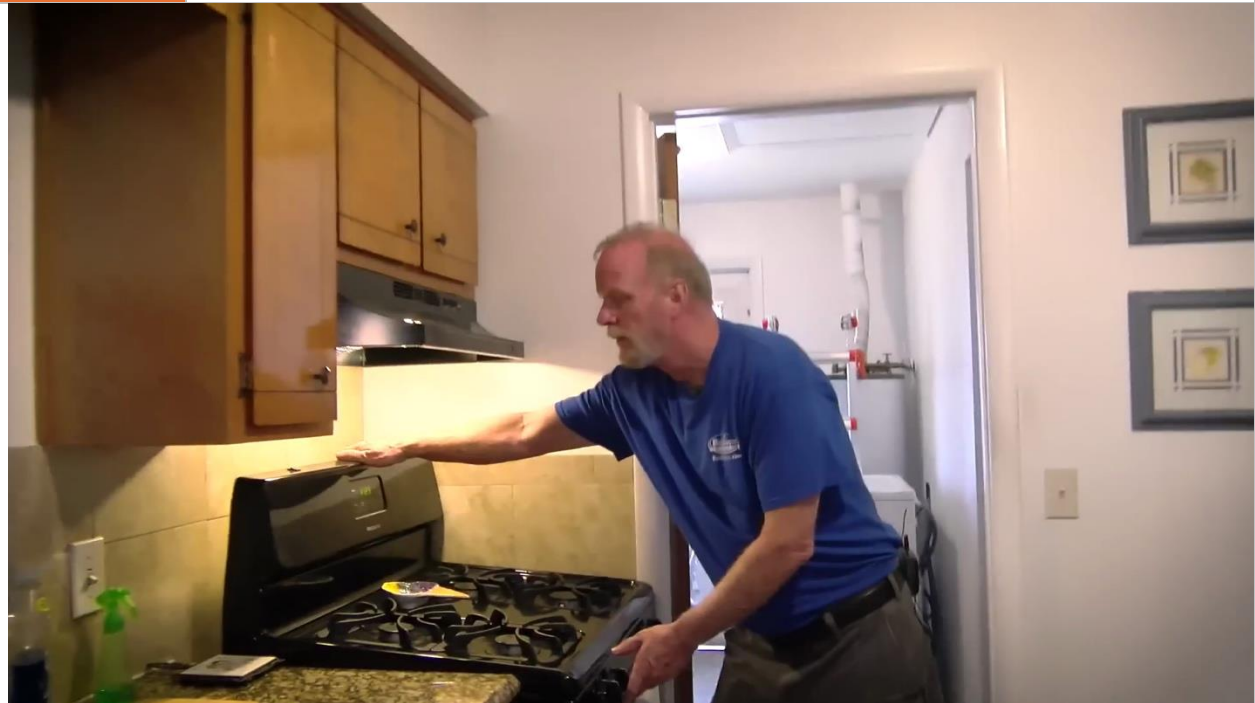
<b>S</b>	<b>Safety (Immediate Concern):</b> The stove lacks an anti-tip bracket. This is a major safety issue, especially for homes with children.
----------	---

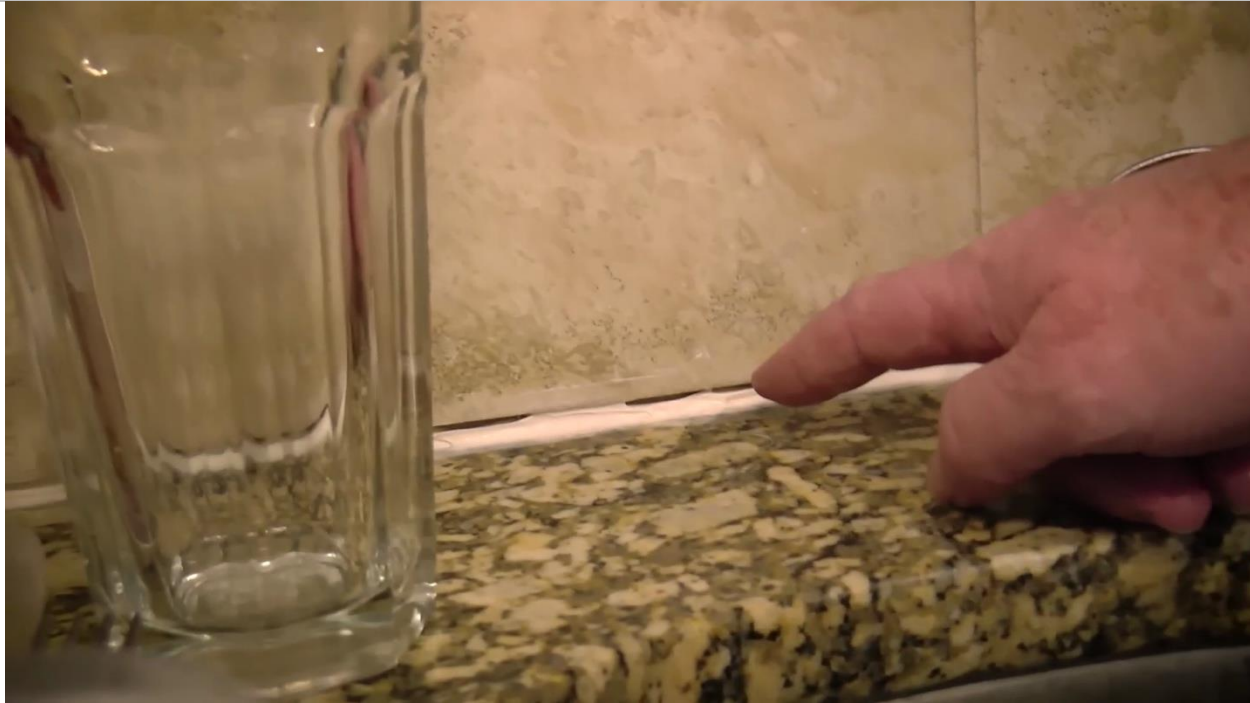
**G** **General Repair:** Caulking around the countertop needs improvement to prevent moisture intrusion.

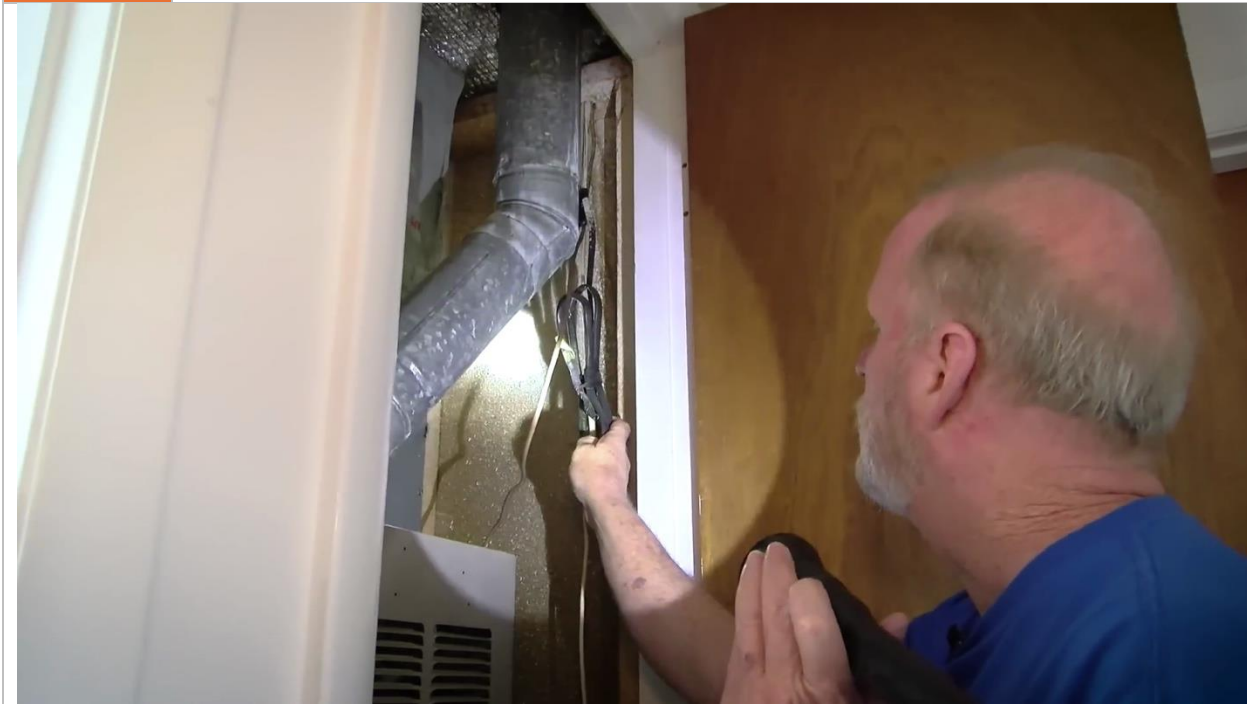
**S** **Safety (Immediate Concern):** There is an exposed electrical conductor terminating in midair near the furnace. This should be properly enclosed in a junction box to prevent potential electrical hazards.

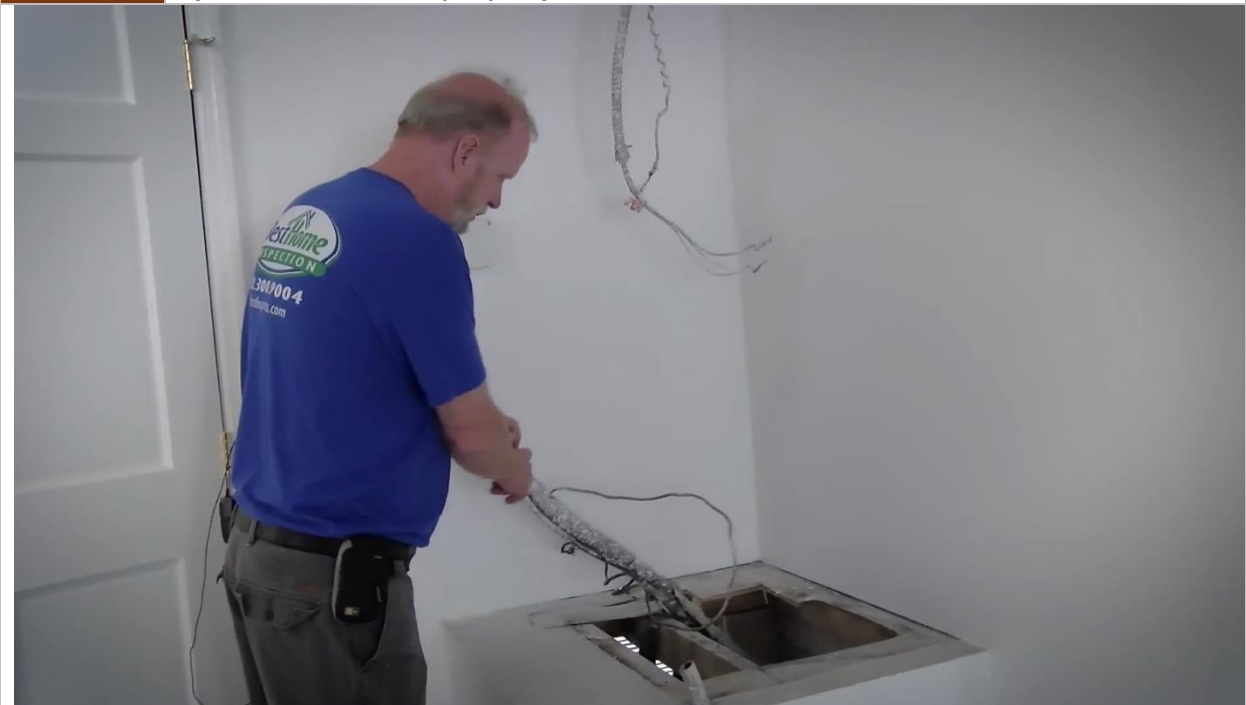
<b>M</b>	<b>Defect (Major Concern):</b> The air handler is missing from the system. This is a crucial component of the HVAC system and needs to be replaced for the system to function properly.
----------	---

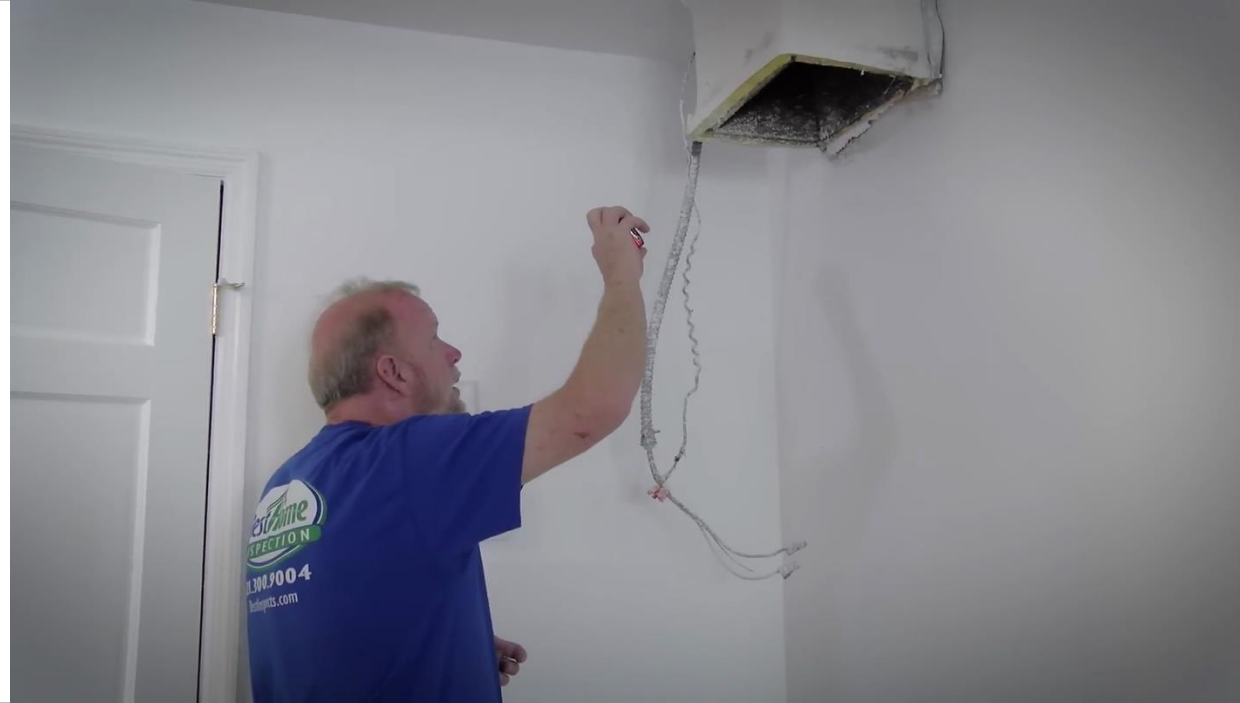
**G** **General Repair:** The existing ductwork appears dirty. It's recommended to have the AC contractor replace as much of the ductwork as possible and thoroughly clean the remainder.

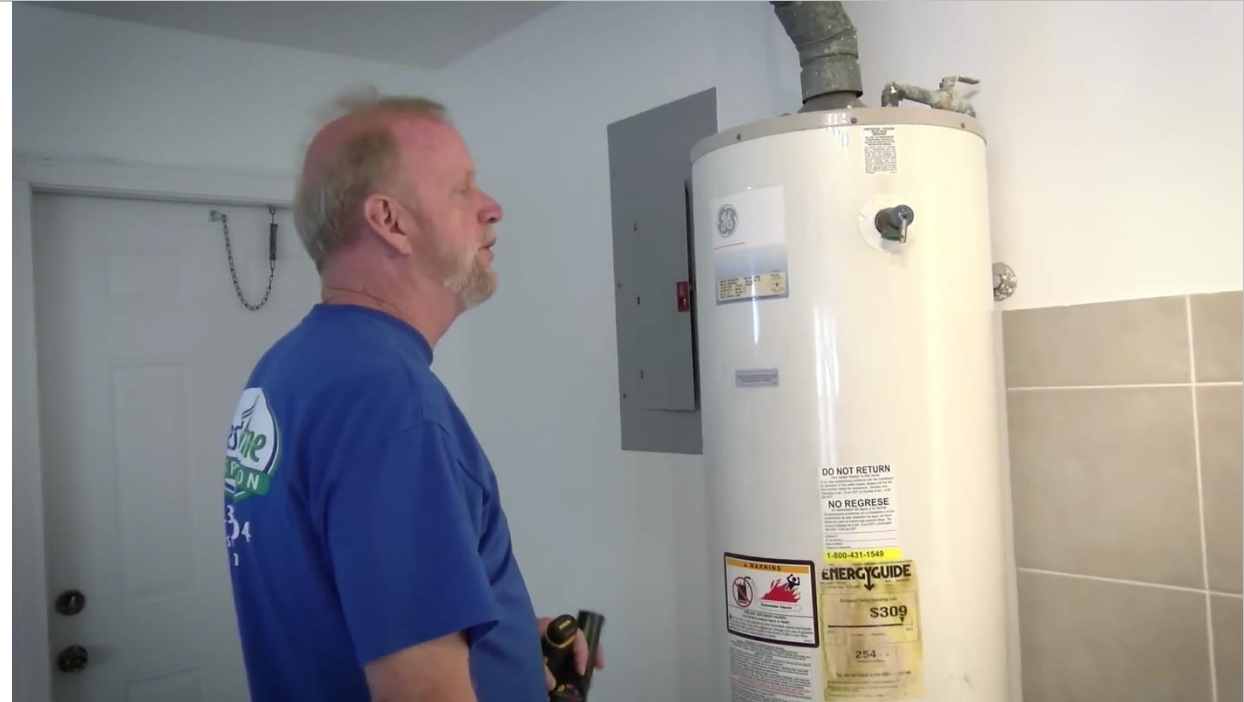
<b>S</b>	<b>Safety (Immediate Concern):</b> The temperature and pressure relief valve's discharge tube is too short. It should extend to within a few inches of the ground to prevent potential scalding injuries if the valve activates.
----------	--

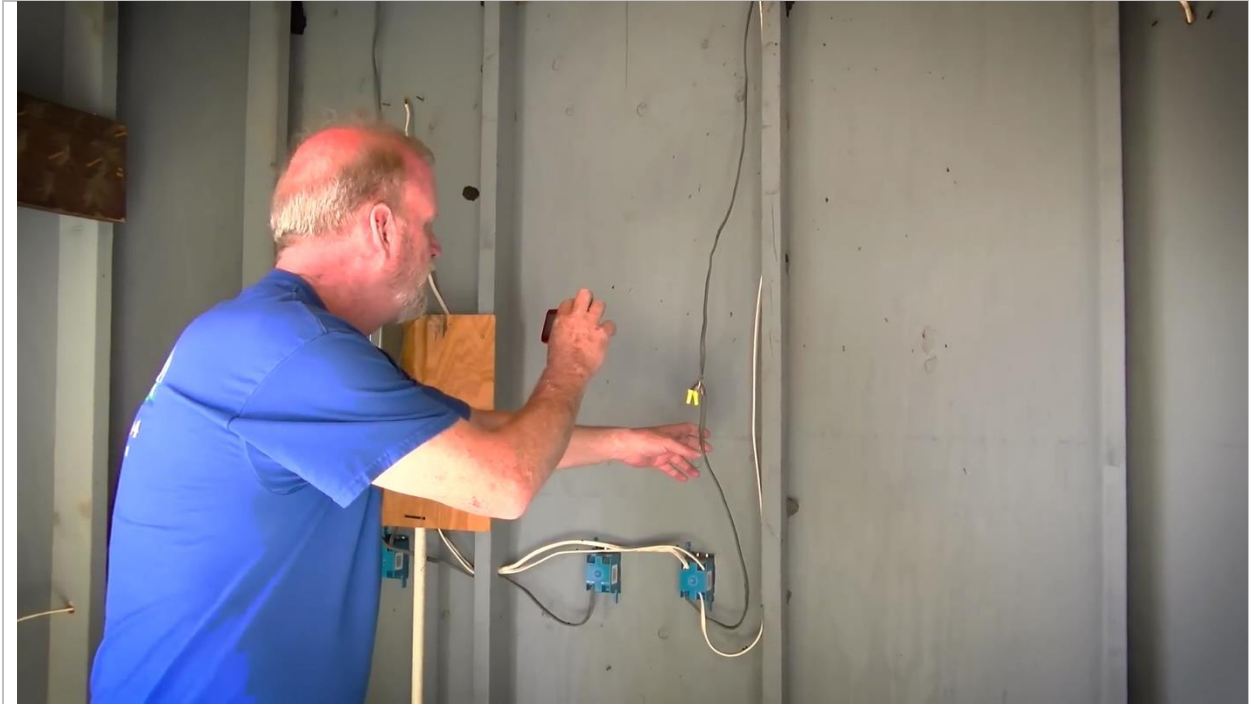
**General Repair:** A spliced wire was observed near the electrical panel in the shed. This splice is not properly contained in a junction box, which is a potential safety hazard.

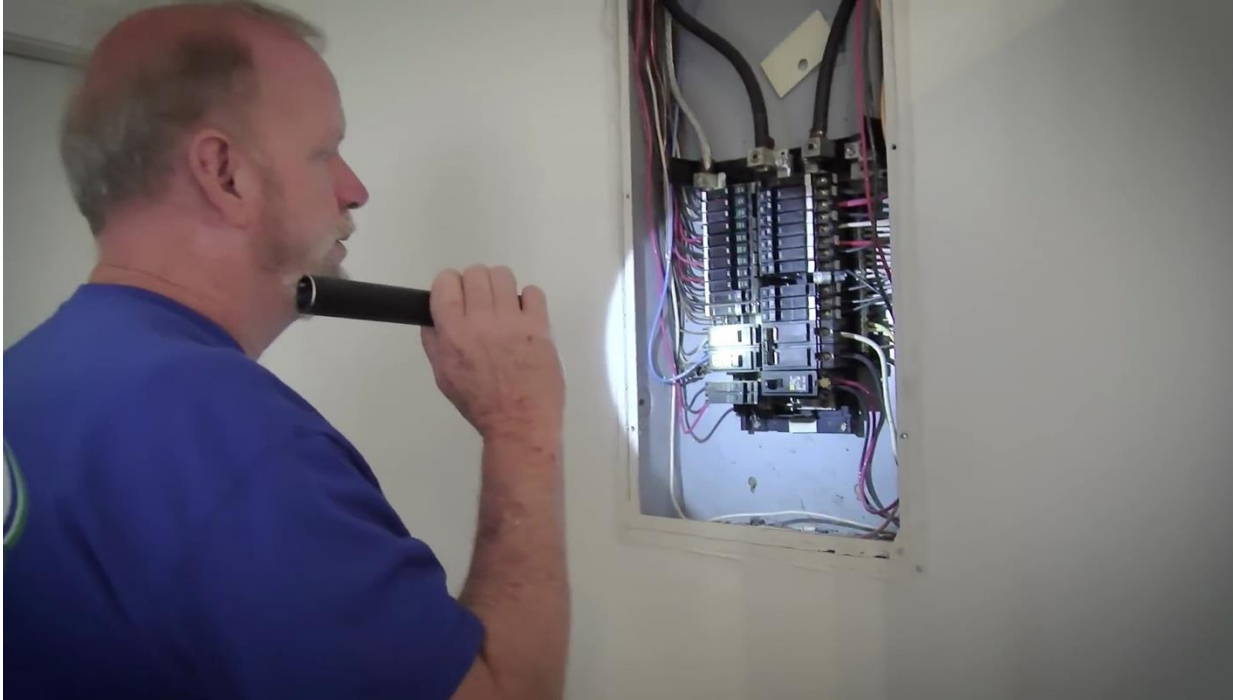
**Safety (Immediate Concern):** The panel contains breakers from different manufacturers (GE, Challenger, and Square D) in a GE panel. This is not recommended and could pose a safety risk. The non-GE breakers should be replaced with appropriate GE breakers.

<b>G</b>	<b>General Repair:</b> As mentioned above, some breakers are from different manufacturers than the panel. These should be replaced for proper compatibility and safety.
<b>F</b>	<b>Functional:</b> Most circuit breakers appear to be in good working condition. No signs of overheating or other issues were detected during the inspection.

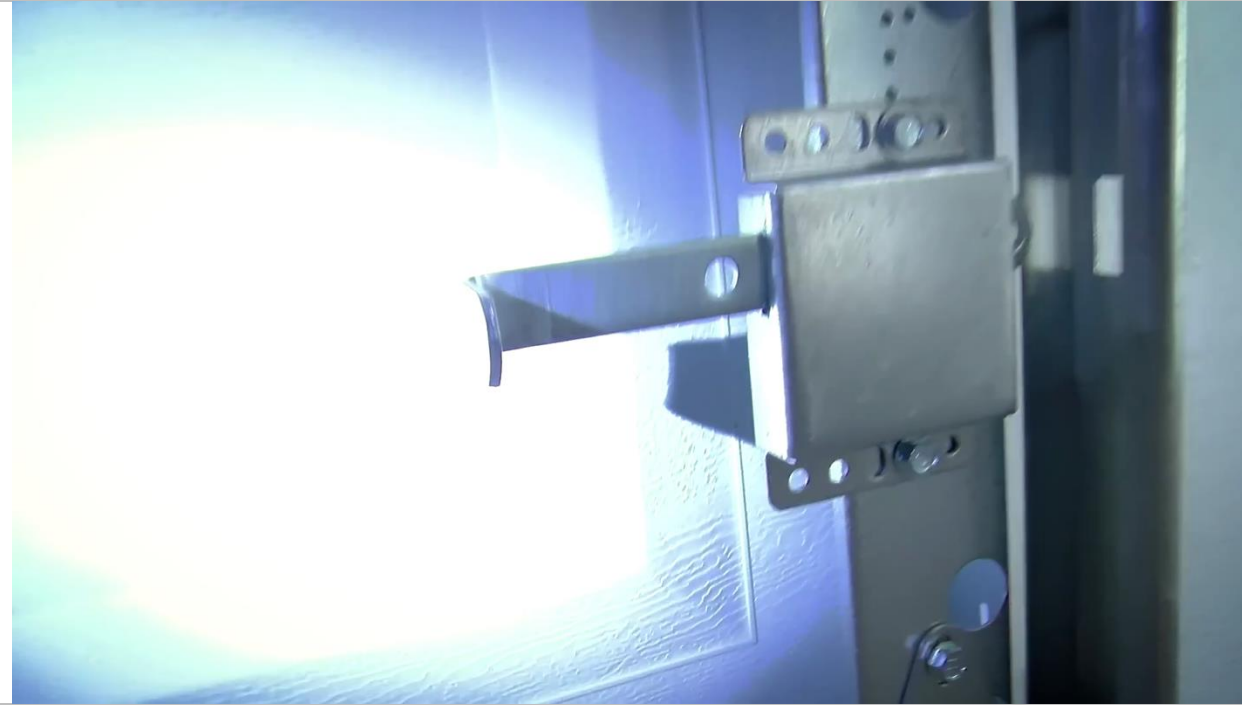
<b>S</b>	<b>Safety (Immediate Concern):</b> It's recommended to install a bolt and nut in a specific hole on the garage door mechanism to prevent accidental disengagement, which could lead to damage or injury.

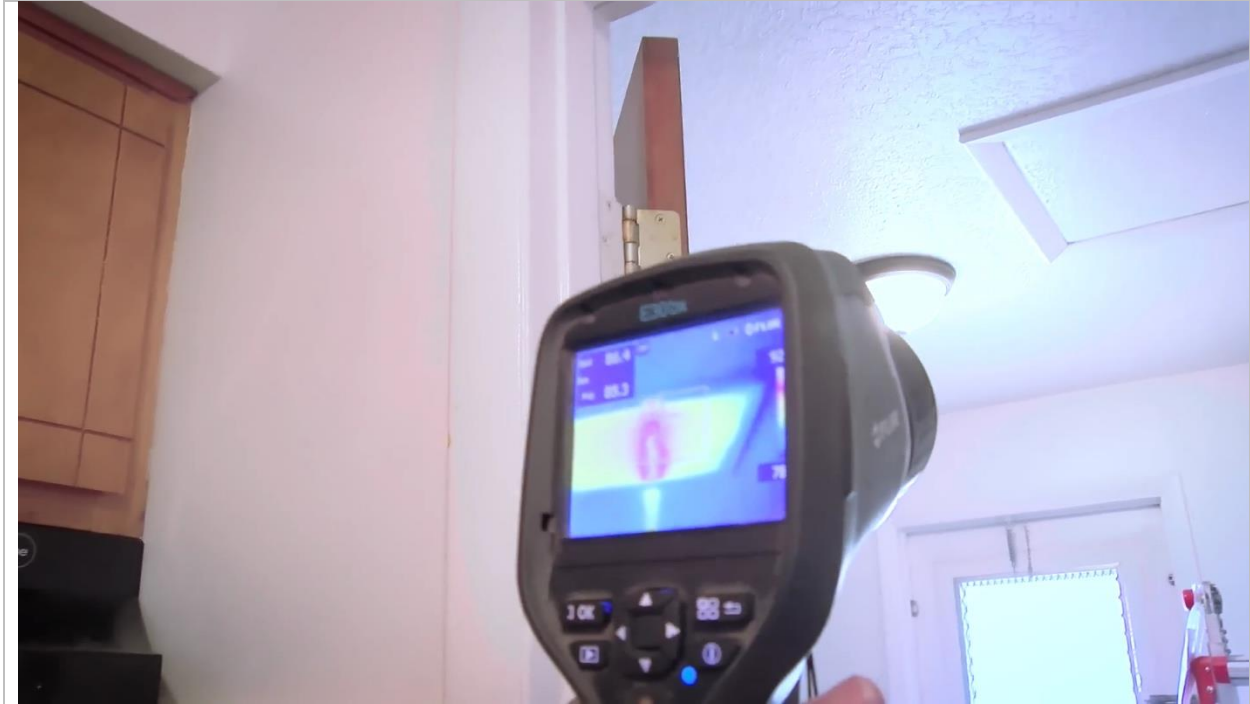
- G** **General Repair:** The infrared camera scan revealed that there is no insulation above the attic hatch. This area should be insulated to improve energy efficiency.

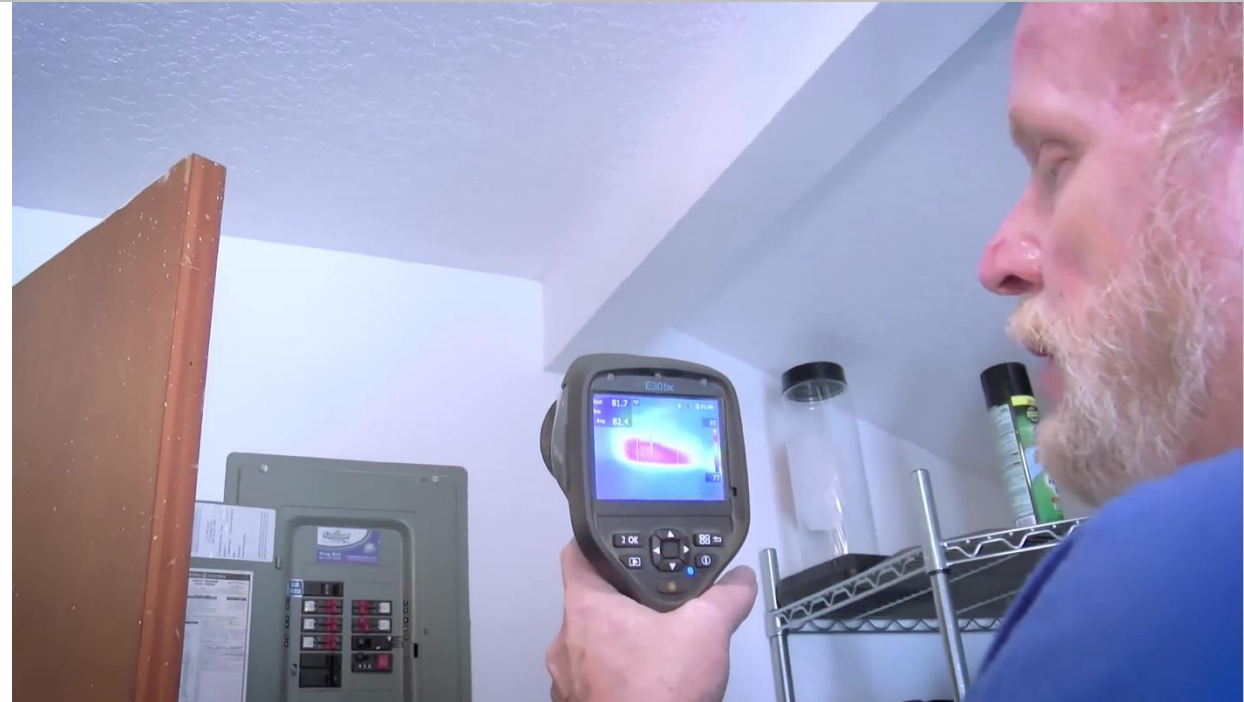
**G** **General Repair:** Insulation is missing from the edges of the house near the soffit vents. This is a common issue resulting from hurricane damage in 2004 and 2005. Adding insulation to these areas would improve the home's energy efficiency.
